CAPITAL CASCADES TRAIL SEGMENT 4

A White Paper on Stormwater Management System Design Practice in Florida

BLUEPRINT    
INTERGOVERNMENTAL AGENCY

November 2022

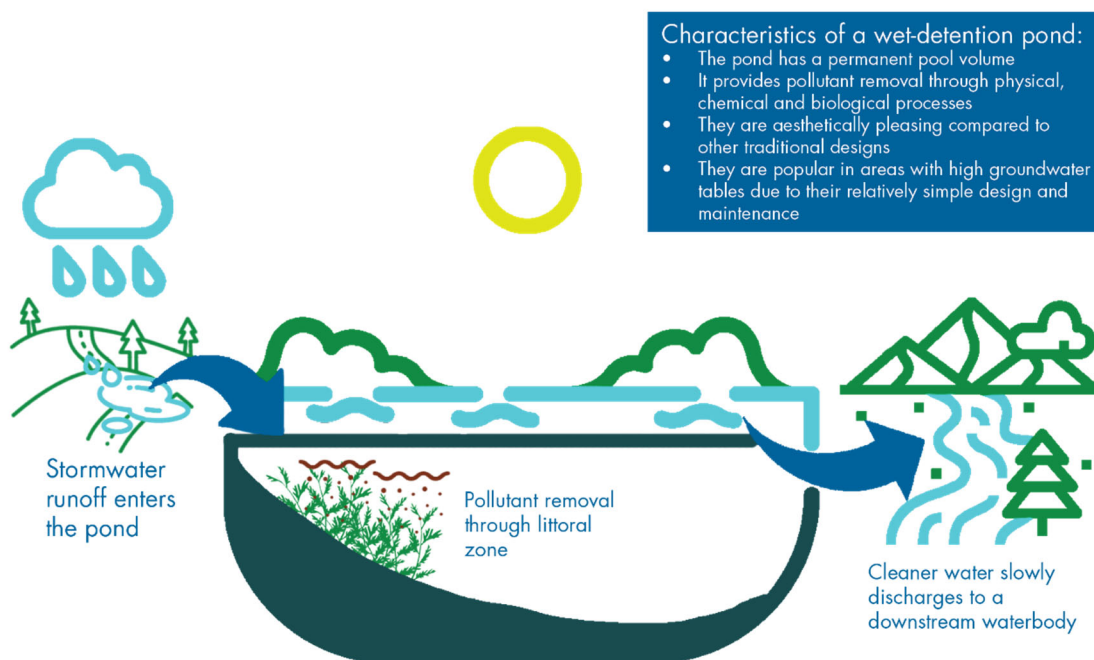
Figure 1 Wet Detention Pond Example

Wet-detention designs are typically a man-made pond that receives stormwater runoff from a storm-drain or swaled system and slowly discharges the captured runoff through a control structure to a downstream waterbody as shown in Figure 1. The pond volumes and control structure discharge rates are engineered to meet presumptive design criteria. The wet portion of the pond is also known as the permanent pool volume.

Wet-detention ponds often incorporate a littoral zone to further facilitate pollutant removal. The littoral zone is a portion of the pond that is designed to be shallow and contain rooted aquatic plants. The aquatic plants promote nutrient removal primarily by providing a habitat for microorganism activity and provide limited direct nutrient uptake. However, several studies have shown most pollutant removal from wet-detention ponds occurs within the permanent pool volume and that pollutant-removal potential is well correlated to the hydraulic residence time of this volume. Simply stated, the bigger the wet-detention pond the higher potential pollutant removal.

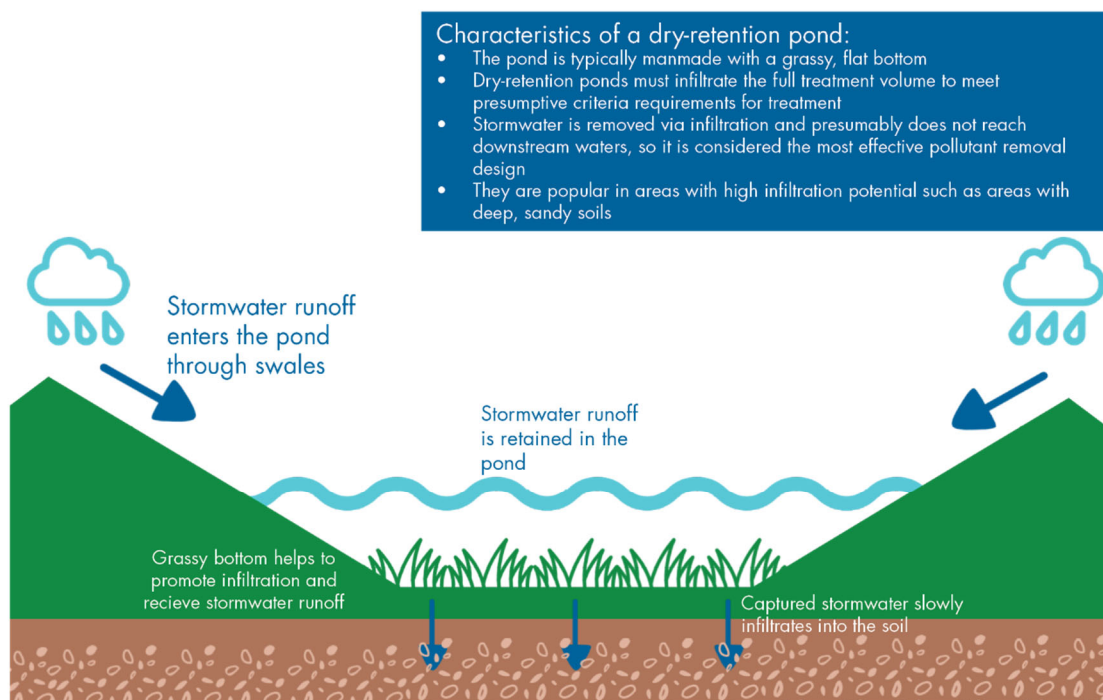
Figure 2 Dry Retention Pond Example

The most common infiltration-based design is a dry-retention pond. These ponds are typically manmade with a grassy flat bottom to promote infiltration as shown in Figure 2 and receive stormwater runoff from a storm drain or swaled system. Dry-retention ponds typically

infiltrate the full volume of runoff received from smaller storm events and slowly release the attenuation volume through an engineered control structure to meet presumptive criteria requirements for attenuation for larger storm events.

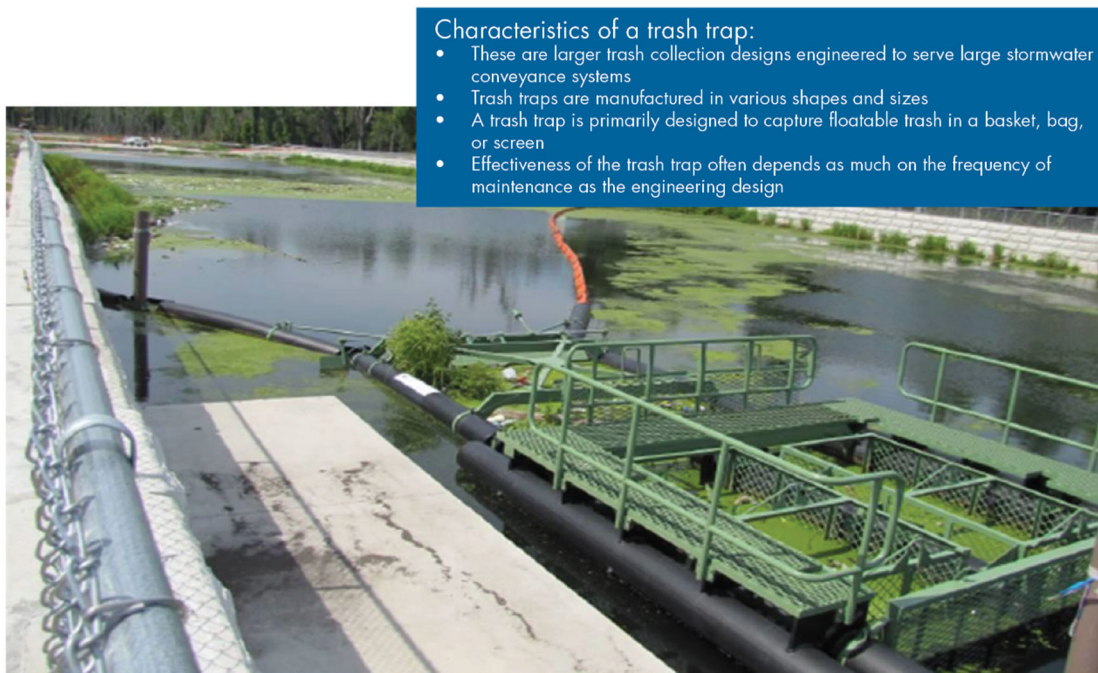
Figure 5 Trash Trap Example

are commonly referred to as trash traps. An example of a large trash trap is shown in Figure 5 and as seen in the figure, trash traps are commonly supplemented with a floating boom that directs trash on the surface to the trap. Baskets and bags typically float and capture trash directly. By comparison, a trash screen typically does not float and captures trash within most or all of the water column.

Simply stated, trash traps are capture points for trash that allow relatively easy removal and maintenance compared to removing trash from a larger stormwater system, such as an open channel or pond. Trash traps do not provide stormwater attenuation. Two primary complicating factors exist with all trash traps:

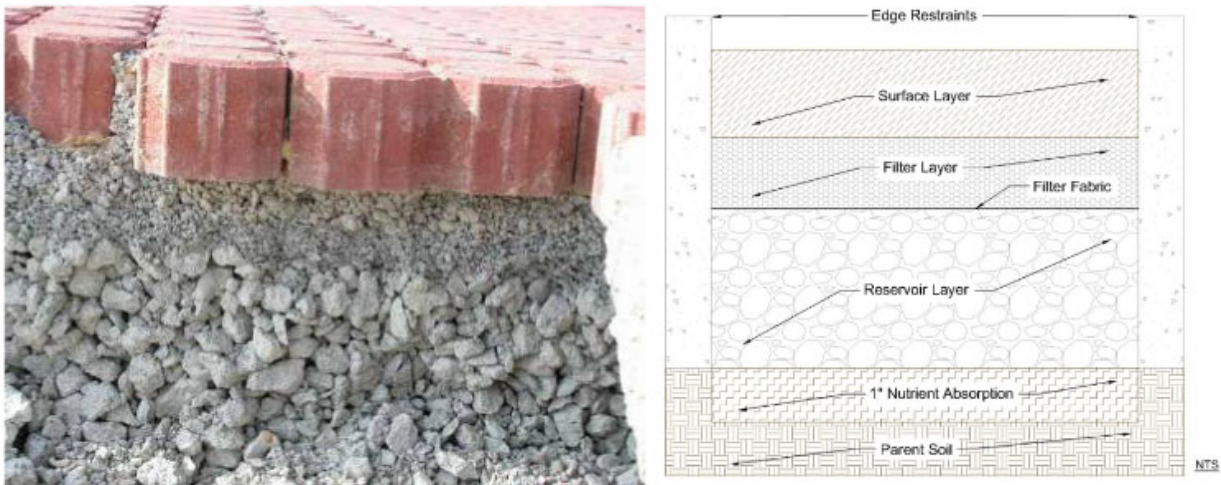
Figure 8 Permeable Pavement Example

Permeable pavement is an infiltration-based design component that uses gray infrastructure. The pavement, concrete, pavers, turf, or other manufactured surface type is porous and allows runoff to infiltrate through the surface to a below-grade system where stormwater attenuation and treatment are provided. Accordingly, permeable pavement systems are more than just the manufactured surface and typically include multiple layers that make a modular system, such as permeable pavement, filter layer(s), reservoir, and subgrade/parent soil as

shown in Figure 8. Permeable pavement is most applicable in areas with infrequent traffic and light loads.

Permeable pavement systems may also include underdrains, where the system will perform like detention with filtration. Stormwater that passes through the permeable pavement system but is ultimately discharged to downstream waters via underdrains typically receives only minimal treatment unless the modular system includes engineered media.

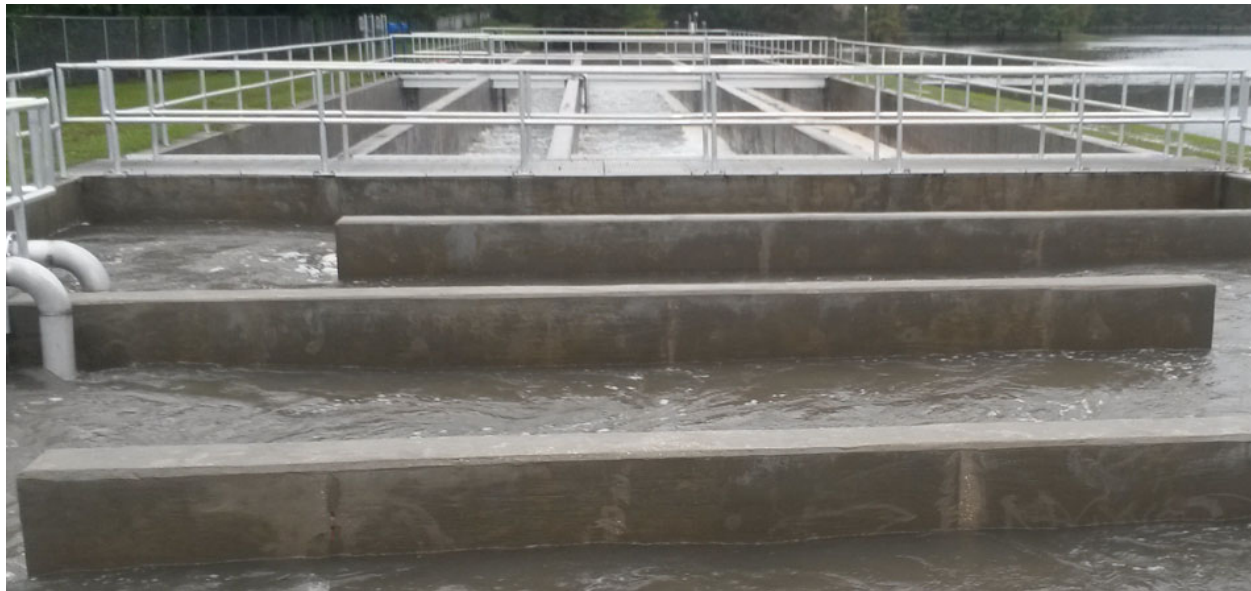
Figure 9 Chemical Treatment Example – ULLNRF Contact Chambers

Chemical treatment systems that use alum are very effective at phosphorus removal but are relatively expensive and require significant maintenance. They are most applicable immediately upstream of a protected waterbody and are often considered as a last resort when all other treatment options have been exhausted. The City operates multiple alum treatment facilities, including one of the largest facilities in Florida, in the Upper Lake Lafayette watershed, known as the Upper Lake Lafayette Nutrient Reduction Facility (ULLNRF) and pictured in Figure 9.

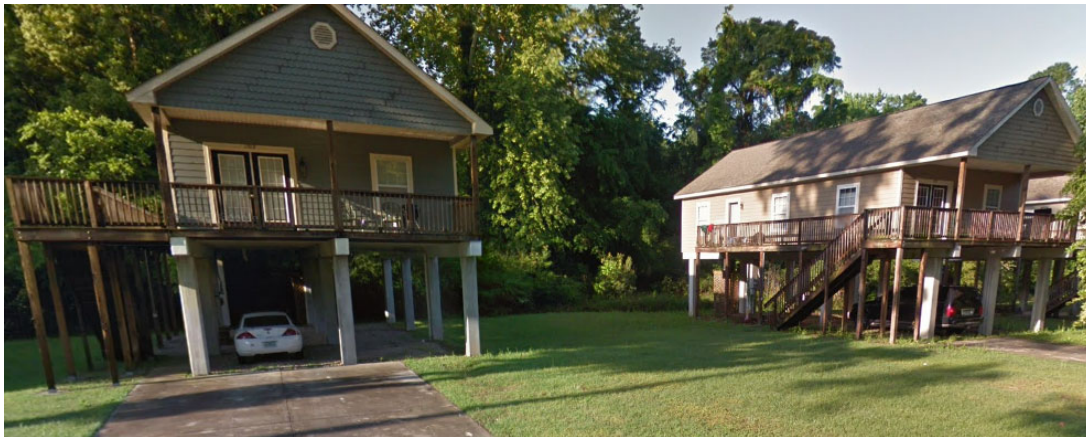
Figure 13 Flood Protection Example – Elevated Homes Along McPhearson Drive

Residential areas near the downstream portion of the CDD, near the CCT Segment 4 project, are known to be susceptible to flooding. Flood conditions in this area are exemplified by the homes along McPhearson Drive, which are elevated on stilts as shown in Figure 13. Residents in Liberty Park have also experienced flood conditions in the past.

Based on available stage gauge data, past modeling efforts, and observations relayed by City and County staff, the known flood conditions in Liberty Park and along McPhearson Drive are more likely driven by hydraulic conditions within Munson Slough rather than hydraulic conditions within the CDD. A more robust stormwater analysis will be performed as part of the CCT Segment 4 project to better understand the potential backwater effect from Munson Slough on the project and adjacent residential areas.
